Re: PLN2021-00478: Coastside Design Review Permit, Coastal Development Permit (CDP), and Variance for construction of a new 1,670 sq. ft. three-story single-family residence with an attached 371 sq. ft. garage and a 791 sq. ft. Accessory Dwelling Unit (ADU) on a legal 7,070 sq. ft. parcel associated with a hearing-level CDP and Variance. The Variance is being sought to allow a reduced front yard setback of 3 feet where 20 feet is the minimum allowed due to the site's location within a portion of the Montecito Riparian Corridor and associated 30-foot riparian setback. APN 047-105-020. Address: 779 San Carlos Avenue, El Granada. The project is appealable to the California Coastal Commission.

As the owner of the adjacent property at 771 San Carlos Ave, I write to object to the abovereferenced project for the following reason:

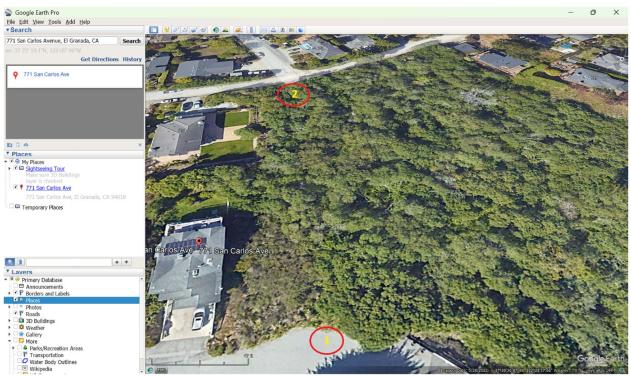
Google Earth Aerial Overview

Exhibit A. This screenshot shows the parcel at 779 San Carlos with the healthy willow thicket covering the riparian area, below which several branches of San Agustin Creek (aka Montecito Creek) meander. The perspective is downhill from San Carlos Ave looking toward Balboa, where a row of sandbags and many ad hoc drains attest to the frequent winter flooding at the site. The numerals 1 and 2 indicate the approximate location of the photographs I took in the fall of 2024 and the winter of 2025. Our house (771) is on the left. Image captured Richard Klein February 9, 2025. Photos from numeral 1 showing that willow dripline extends about three feet onto the lot near San Carlos Ave.

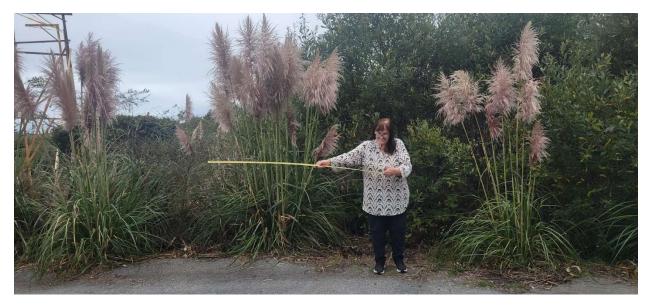
Exhibit B. My wife, Kathy Klein, stands at the property line (numeral 1 in the overview) with a measuring tape. Note the story poles to the left. The end of the measuring stick marks the dripline of the willow canopy, marked with red tape. It is clearly only about 15 feet from the willows to the proposed house. Photo Richard Klein September 28, 2024.

The proposed building would not respect the riparian zone boundaries and appears to come within 15 feet of the riparian zone boundary as evidenced by the "drip line" of the healthy arroyo willow canopy which is adjacent to, and in some cases extending into, the site. A minimum 30-foot buffer is required. Once the story poles went up in the fall, visual inspection made it obvious that the plans incorrectly place the riparian boundary.

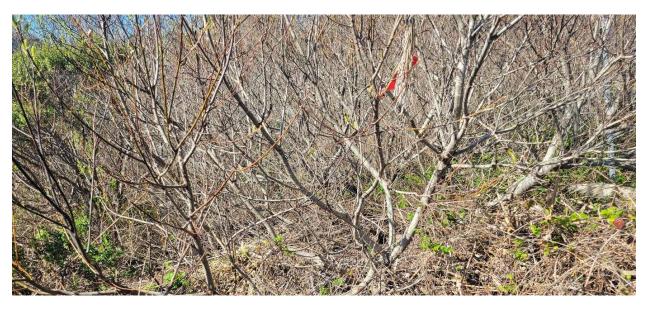
Exhibit C. Closeup of the willow canopy behind Kathy with the red tape on a willow branch. Photo Richard Klein February 8, 2025.

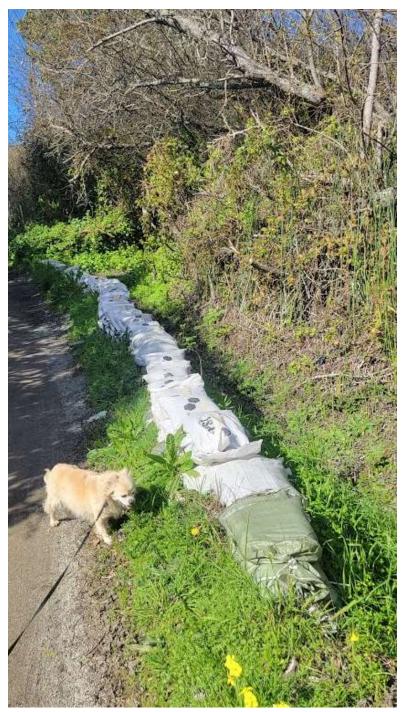
Exhibit D. Sandbags on Balboa, ready for winter rainfall. Our tiny dog Charlie for perspective. Willow trees and horsetail in the vegetation on the right. Photo Richard Klein February 8, 2025.

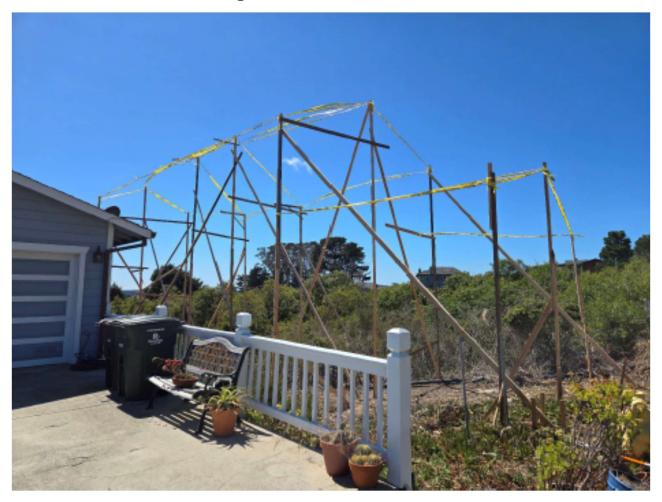
Exhibit F. Photo taken from application shows the story poles in the foreground and the nearby willow thicket behind. The willows in background right are at approximately the location of numeral 1. Photo unknown photographer and date between September and January.

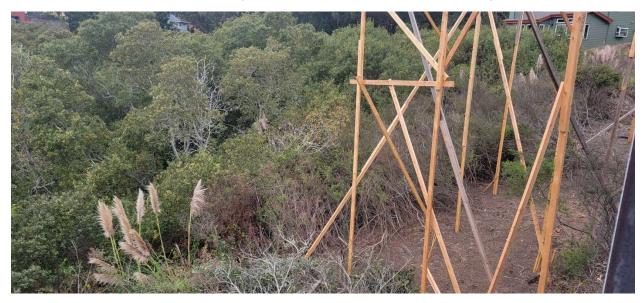
Exhibit G. View from our family room with story poles in foreground and willow branches almost touching rear of structure. Photo Richard Klein September 28,2024.

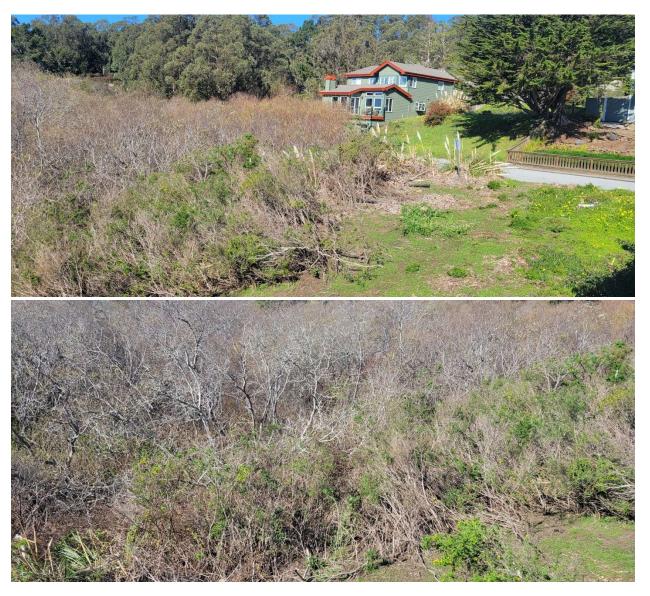
Exhibit H. First photo looks toward numeral 1 on the street. Second photo looks straight out from our window to the willows, with a small amount of uncleared French Broom in the foreground. The willows are just starting to show their new leaves and catkins. Photos Richard Klein February 9, 2025.
